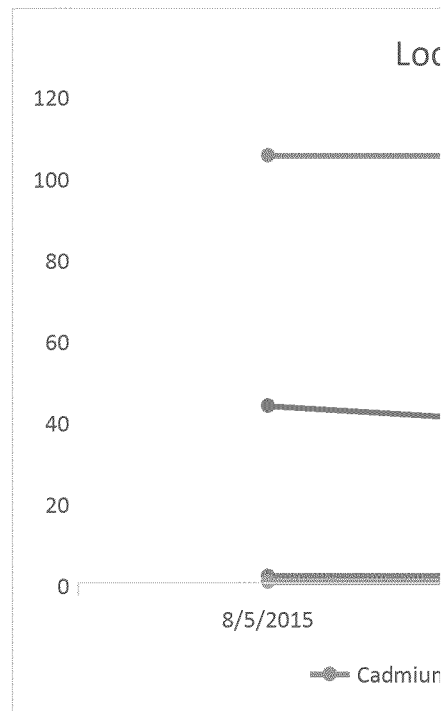
ocation ID	Date Sampled	Cadmium	Copper	Lead	Manganese	Zinc
32nd St Br	8/5/2015	0.178	1.7	0.24	105	43.5
32nd St Br	8/6/2015	0.16	1.56		105	37.8
32nd St Br	8/6/2015	0.19	1.62	0.115	97.8	49.1

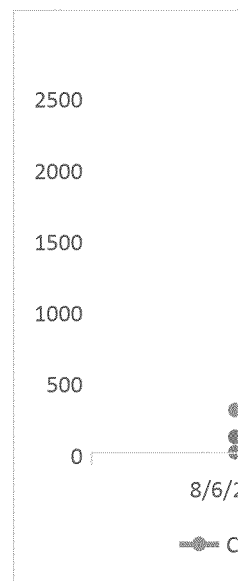
Location ID	Date Sampled	Cadmium	Copper	Lead	Manganese	Zinc
Bakers Bridge	8/6/2015	0.336	1.88		296	110
Bakers Bridge	8/6/2015	5.32	189	1.56	2090	1700
Bakers Bridge	8/5/2015	0.353	2.28		306	85.8

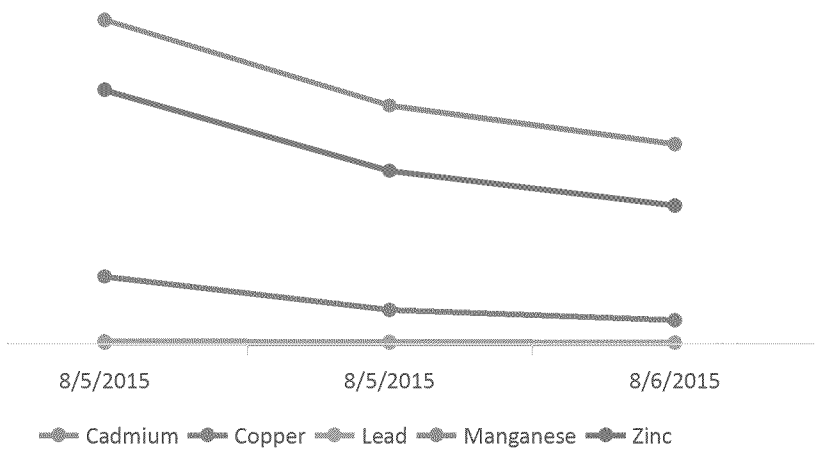
Location: CC48

ocation ID	Sampled	Cadmium	Copper	Lead	Manganese	Zinc
CC48	8/5/2015	30.6	2260	73.9	10900	8540
CC48	8/5/2015	19.1	1130	54.1	8020	5820
CC48	8/6/2015	14.2	786	30	6720	4650
